# YELLOWSTONE COUNTY

TRAFFIC SAFETY

IMPROVEMENT

STUDY

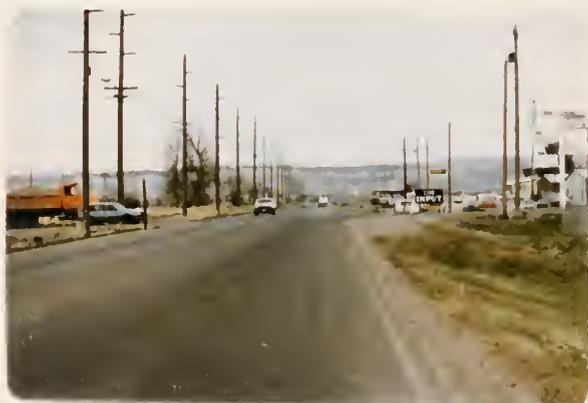
KING AVENUE W. EAST ↑

The lack of noticeable roadside friction for sizeable distances on each side of the intersection on King Avenue West causes vehicle speeds to be greater than the posted 45 mph. The estimated 85% speed

would probably be closer to 55 mph than 45 mph. The degree of speed combined with heavy turning movements at the intersection, flat and open topography and an inadequate pavement width for avoidance maneuvering, create a potentially dangerous situation for inattentive drivers.
